Background

Case from: Dr. med. Dr. med dent. Oliver Lys, Switzerland

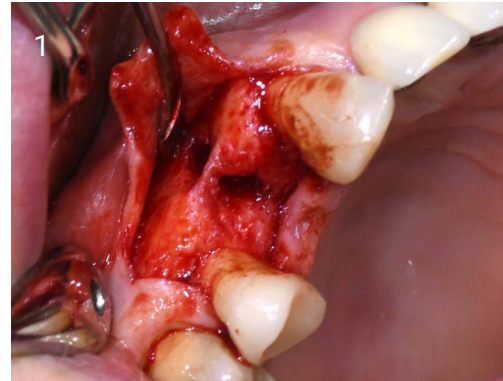
1. Bone defect with fenestration after extraction.

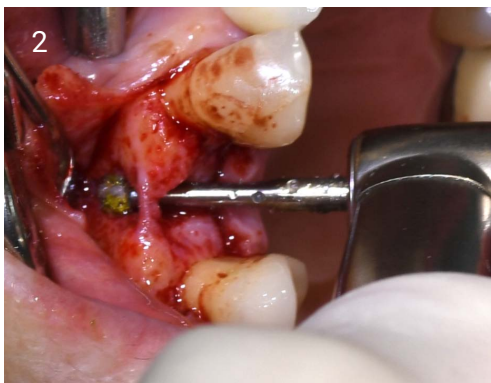
2. Complete removal of granulation tissue with EthOss® Degrgranulation Burs.

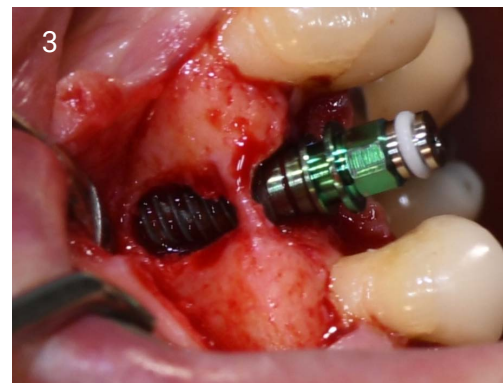
3. Implant with mount, bone defect visible.

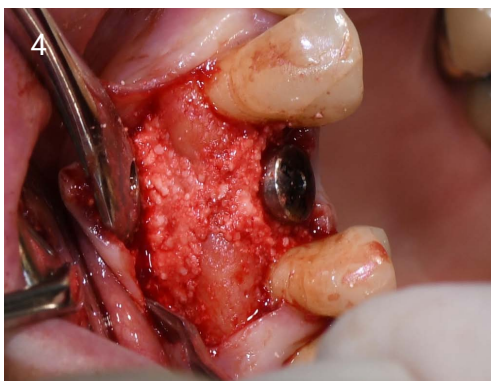
4. Bone defect filled (and modelled) with EthOss®.

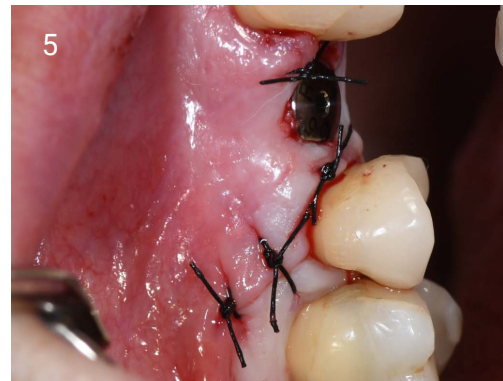
5. Closure with single sutures.

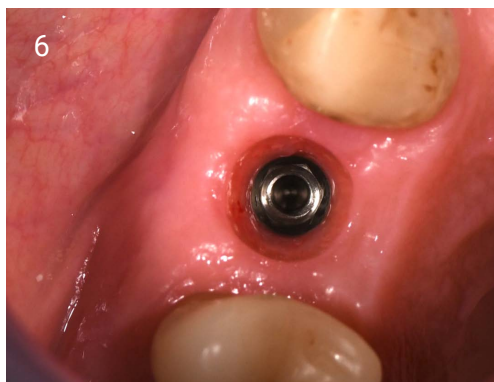
6. Soft tissue healing 16 weeks following graft procedure.

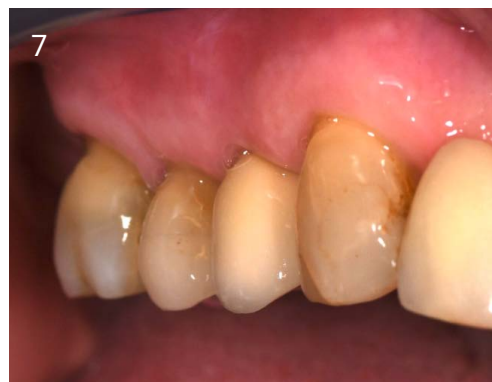
7. Final result at 16 weeks.

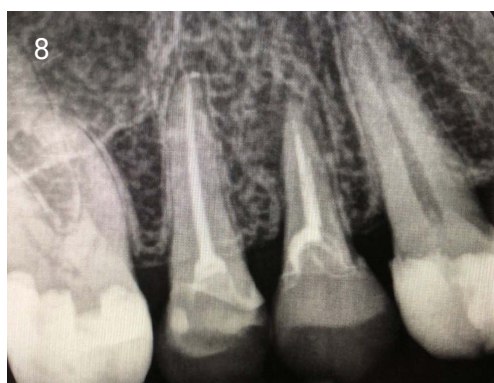
8. Initial x-ray - tooth 14 periapical lesion.

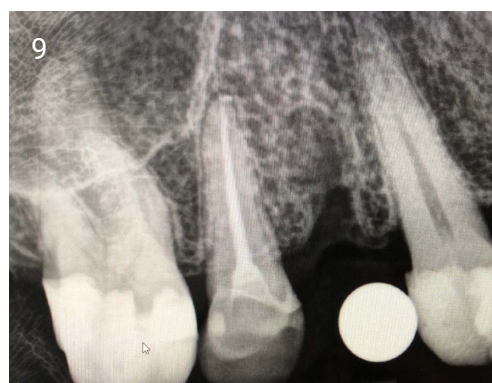
9. X-ray immediately after extraction with reference ball.

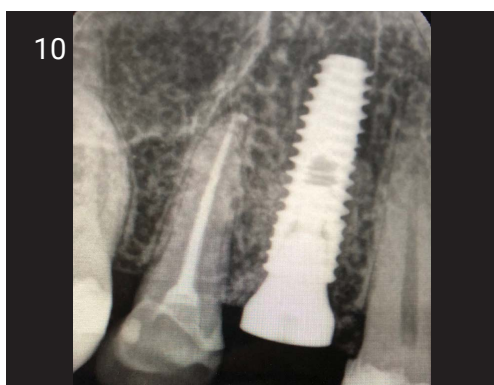
10. X-ray at implant placement.

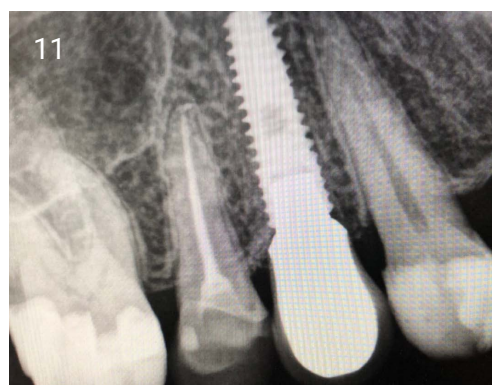
11. X ray after 16 weeks showing stable bone.
